NSTAR Extended Life Test Discharge Chamber Flake Analyses

Kim K. de Groh and Bruce A. Banks
Glenn Research Center, Cleveland, Ohio

Prepared for the
40th Joint Propulsion Conference and Exhibit
cosponsored by AIAA, ASME, SAE, and ASEE
Fort Lauderdale, Florida, July 11-14, 2004

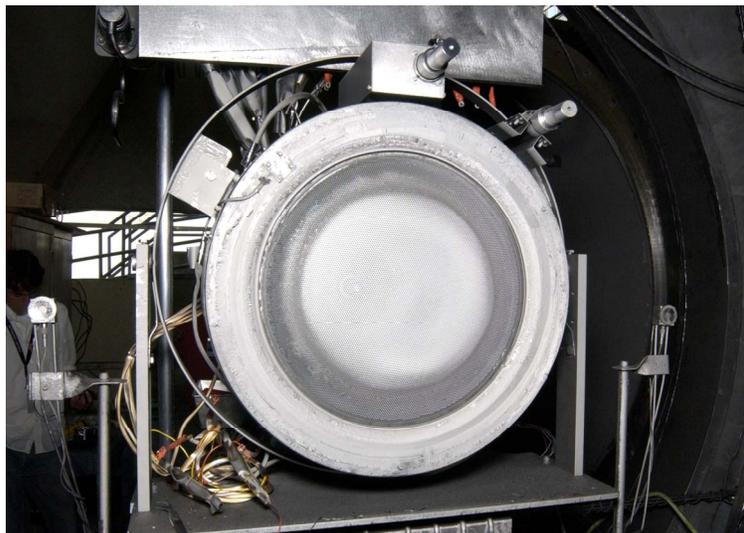
Figure 1. NSTAR ELT Ion Thruster after 30,352 hours of operation.

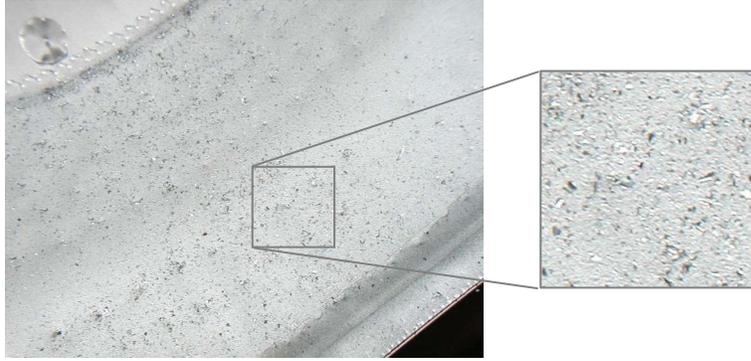
Post-test inspection of the ELT engine revealed numerous small contaminant flakes uniformly distributed over the bottom of the cylindrical section of the discharge chamber (DC), as shown in Figure 2. Flakes were not observed on the conical area of the DC. The presence of these flakes was unexpected. Internally generated flakes are a major threat to thruster reliability and durability because they can potentially short the ion optics or the cathode. If the flakes are externally generated (from the facility) then these flakes are not a threat to in-space reliability and durability. Therefore, it is important to determine the origin of the flakes, which is critical to the understanding of degradation mechanisms of long life ion thruster operation. The contaminant flakes were therefore collected for evaluation.

Figure 2. Contaminant flakes distributed over the bottom of cylindrical section of the NSTAR DC.

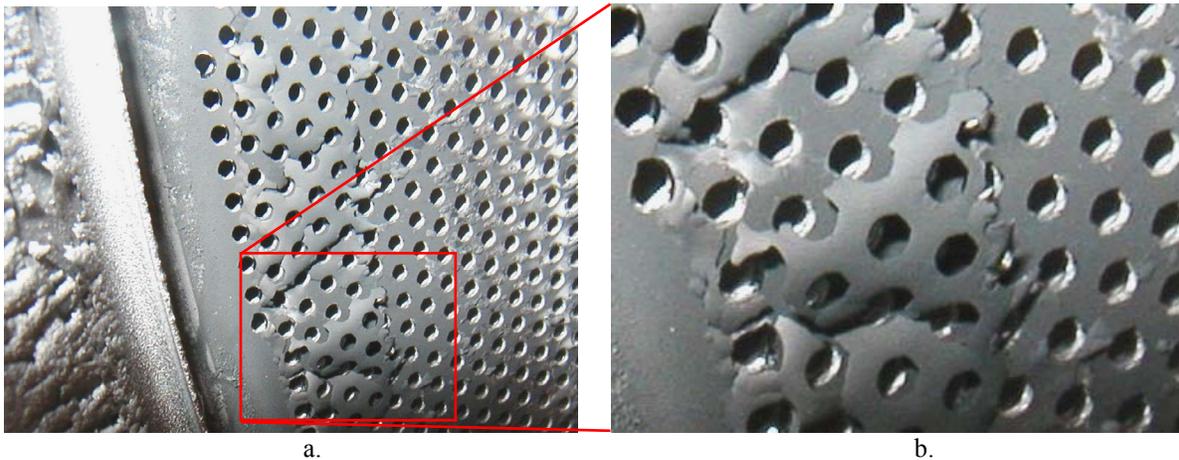
Extensive analyses have been conducted at the GRC on NSTAR ELT DC contaminant flakes to determine the source of the particles (e.g. from within the thruster, from the screen or accelerator grids, or from outside the thruster). Analyses included particle shape and size, surface and edge texture and chemistry, and edge thickness. A particle size histogram was produced. Atomic oxygen exposure tests were conducted on a group of flakes to determine the quantity of carbon present. Samples were collected of loose downstream accelerator grid surface sputter deposited debris. The loose downstream accelerator grid and ground shield surface debris is shown in Figure 3. This photograph was taken at the perimeter of the downstream surface accelerator grid. The downstream accelerator grid debris was analyzed for its composition to provide additional information for verifying the source of DC contaminant flakes. Samples of the anode screen mesh were sectioned and examined for evidence of deposited coating spalling. This paper summarizes the results of the analyses of the DC flakes, the downstream accelerator grid debris and the sputter containment mesh, providing evidence for the source of the particles.

Figure 3. Loose sputter deposited debris on the downstream accelerator grid: a). Perimeter of grid, and b). close-up image of debris shown in a).

Loose flake particles were collected from the downstream accelerator grid surface. These relatively large flakes were in the process of spalling off the surface, as shown in Figure 2, and were easily lifted off. Pieces of the downstream accelerator grid flake pieces were mounted on the SEM holder propped up at angles so that the edges of the flakes were visible for imaging and EDS analyses.

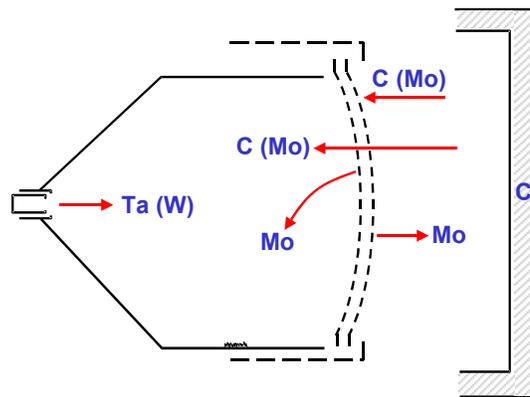
placed inside the vacuum tank downstream of the engine covering the view of the facility tank material (stainless steel), which has a higher sputter yield. This low sputter erosion material is typically called the target. The sputter eroded target material will deposit and coat downstream surfaces of the thruster, and can also enter into the DC, as shown in Figure 4. In the ELT the target material was carbon in the form of graphite panels. During ion thruster operation, both in-space and during ground tests, significant sputter erosion of thruster components also occurs. In particular, the xenon ions sputter erode the up-stream surfaces of the screen grid, and the hole walls and downstream surfaces of the accelerator grid. The grids are comprised of molybdenum (Mo) in the NSTAR engine. The screen grid and (to a lesser extent) accelerator grid hole wall sputter eroded Mo can deposit on the inside of the DC and a thick layer of sputter deposited Mo builds up within the DC during a long-duration test. Therefore, the DC is lined with a sputter containment mesh comprised of a high surface area (grit-blasted) woven stainless steel mesh. The containment mesh was designed to retain the sputter deposited Mo. The high surface area minimizes the stresses that build up as the film gets thick and hence resists spalling of the deposited film. Other sources of sputter deposition inside the DC are from cathode components (the keeper tube comprised of tantalum (Ta), the keeper end cap (Mo), or the cathode orifice plate (thoriated tungsten (W)), also shown in Figure 4.

Figure 4. Schematic drawing showing the primary modes of ion sputter erosion and deposition occurring during the NSTAR ELT thruster test.

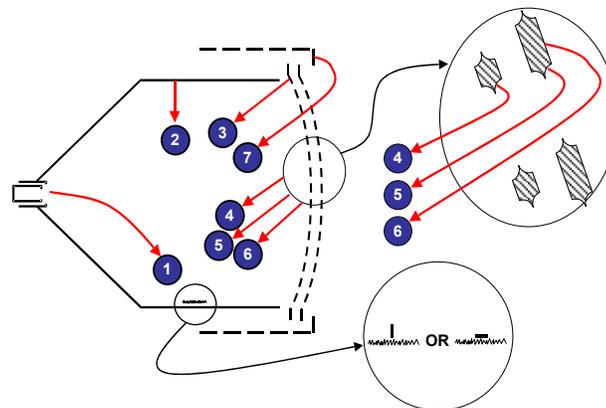
As the ion sputter erosion and deposition processes take place, numerous possibilities exist for building up a thick enough film deposit that can then spall and become a source of contaminant flakes in the ELT ion thruster DC. The most probable source locations for contaminant flakes found in the ion thruster are provided in Figure 5. These include: 1. the cathode keeper area, 2. the anode mesh, 3. the perimeter of the upstream face of the screen grid, 4. the screen grid hole walls, 5. the accelerator grid hole walls, 6. the perimeter of the downstream face of the accelerator grid, and 7. the downstream face of the thruster ground shield. By examining the shape and chemistry of the DC flakes and comparing the results with flakes taken from the downstream accelerator grid surface, and examining the sputter containment mesh, the source of the ELT DC flakes can be determined.

Figure 5. Schematic drawing showing the potential source locations of the contaminant flakes that deposited in the NSTAR ELT DC.

The origins of the flakes could be from 7 different potential locations as indicated in Table 6, and highlighted in Figure 5. The surface morphology and shape of the potential sources gives good indications of the morphology and shape of the resulting flakes that one would expect upon observation of those found in the DC. The maximum size of the flakes generated downstream of each of the grids would not be observed within the DC because the grids prevent the entry of flakes larger than the aperture diameters (except for a few that may enter the grid apertures end-on). If one compares the compositions possible for flakes from the various sources, their potential sizes, shapes and morphologies and the grid hole diameters, one is lead to believe that the flakes have all originated from facility sputter deposited C materials as opposed to internal thruster erosion. The flakes originate predominantly from

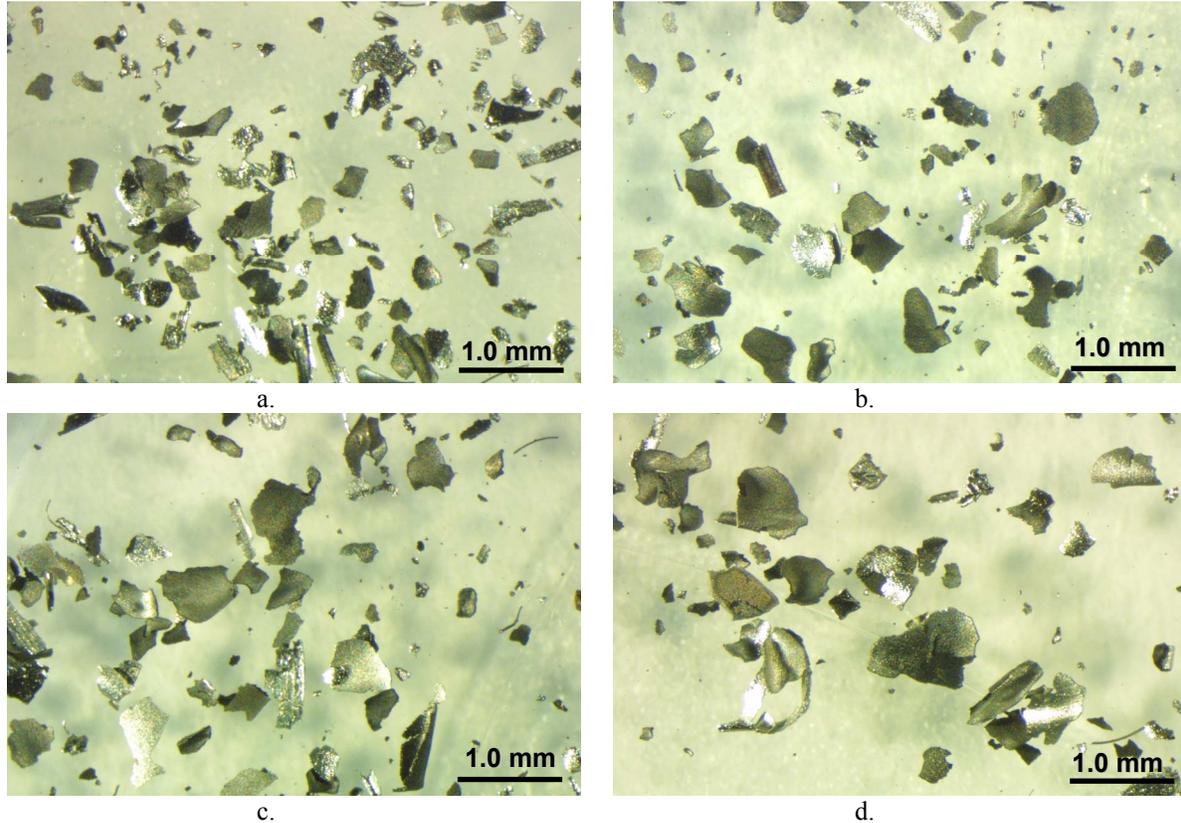
The optical microscopy images of the DC flakes clearly show that there are differences in the appearance of the individual flakes. The flakes differ in color (light, medium and dark) and texture (relatively smooth and shiny or rough), as seen in Figure 6. The shiny flakes have a metallic appearance. This heterogeneity in flake appearance is most likely due to a difference in surface chemistry and corresponding texture. Looking more closely at certain flakes it was observed that some showed differences in color and texture on the same flake. Examples of this type of dual-texture flake are provided in Figure 7.

Figure 6. Optical micrograph images of the DC flakes showing contrasting textures and hues of flakes: a). Image 4260 from DC Flakes 16, b). Image 4239 from DC Flakes 16, c). Image 4300 from Flakes 16 and d). Image 4388 from DC Flakes 17.

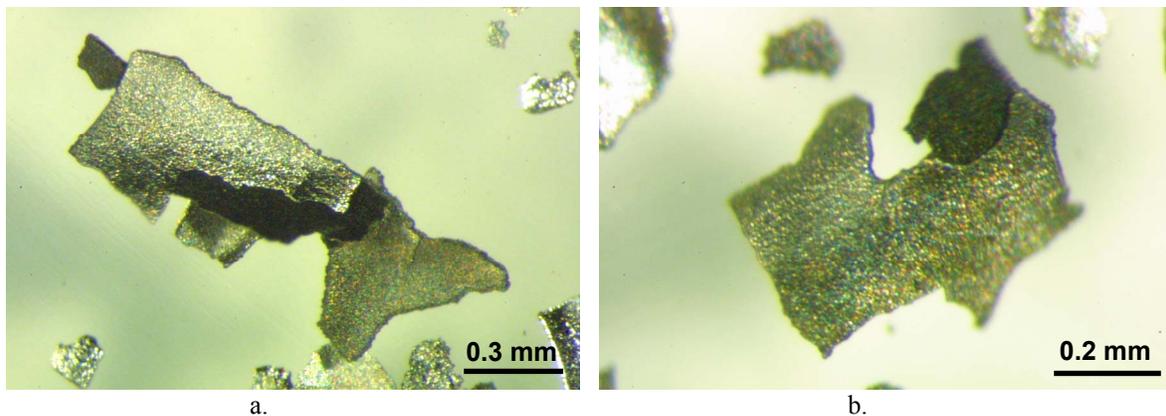
Figure 7. Optical micrograph images of dual-texture flakes showing contrasting textures and hues on single flakes: a). Image 4424 from DC Flakes 16, and b). Image 4459 from DC Flakes 16.

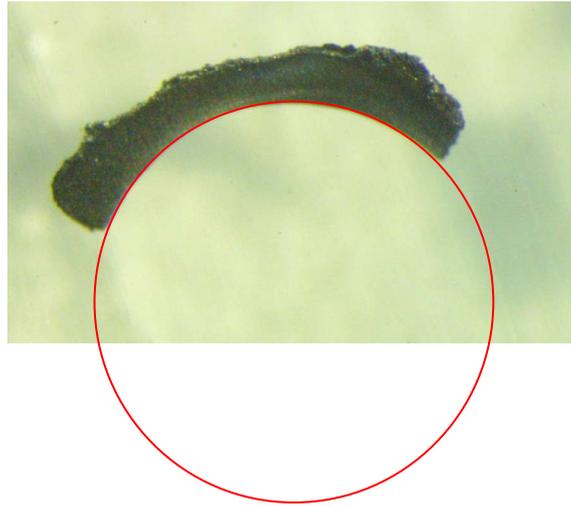
The optical microscope images revealed at least four flakes whose shape suggested that they had spalled from the area around either the screen or accelerator grid holes (i.e. the flakes resided within the grid hole wall). The theoretical diameter of the grid hole from which these flakes may have originated was determined by fitting a circle of a known diameter into the arc of the flakes. An example is provided in Figure 8. Three of the four flakes measured were found to correspond to the post-test accelerator hole diameters, while one is somewhat larger. This is not surprising as it is very likely that because these flakes are under compressive stresses when deposited, they may expand somewhat as they spall and lift off the surface. None of the flakes indicated that they were from the larger screen grid hole wall.

Figure 8. NSTAR DC flake that appears to have resided within a hole wall (Image 4242, DC Flakes 15).

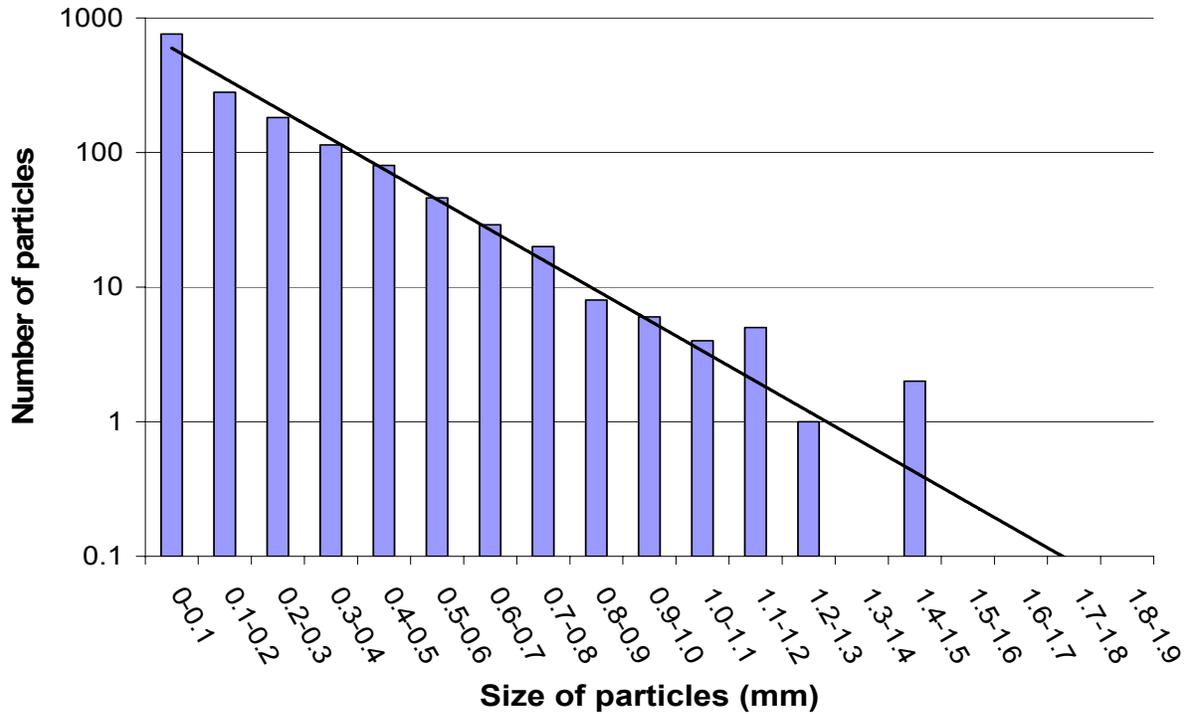
The particle size histogram created from the flake measurements is provided in Figure 9. This histogram shows that a large majority of the flakes are smaller than 0.5 mm in length. As can be seen in the histogram, as the flake size increases the number of flakes decreases. At a length of 0.8 mm and above, less than 10 flakes appeared in each 0.1 mm increment bin. Thirteen flakes were measured to be ≥ 1.0 mm in length that were included in the histogram. It should be noted that not all of the flakes in the DC Flakes 17 container were measured, and none of the DC Flakes 3, 14 or 16 were measured for the histogram, therefore this is a general representation of the flake sizes.

The number of flakes included in the histogram that are larger than the post-test grid gap and therefore could bridge the gap between the grids is 160. Therefore, based on the histogram data, 10.4% of the flakes could cause a short between the grids.

Figure 9. Particle size histogram based on the longest dimension of 1538 flakes (645 from DC Flakes 15 and 893 from DC Flakes 17).

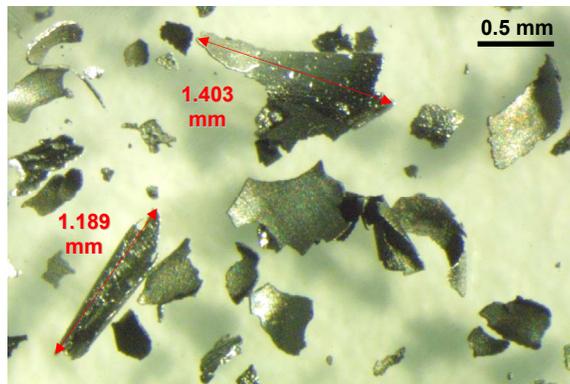
The two largest flakes included in the histogram were 1.403 and 1.430 mm in length. The 1.403 mm flake is shown in Figure 10 below with a 1.189 mm length flake (B2 P10). These flakes, along with all the histogram flakes are consistent with being of a size that could fit through the accelerator grid holes. The histogram therefore indicates that the size of the DC flakes was controlled by the grid hole sizes, with the accelerator grid holes acting like a filter. This indicates that the flakes originated outside the DC. If the flakes had originated from spalling of material on the screen anode, inside the DC, then much longer flakes would have been observed.

Figure 10. Optical microscope image showing two of the largest measured flakes (Image 4445, DC Flakes 17).

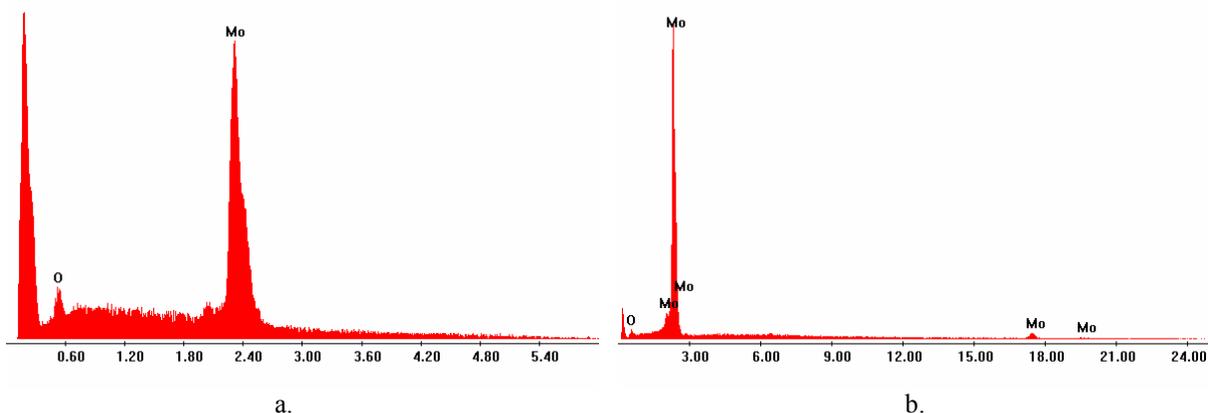
The detector on the FESEM EDS system is very sensitive to light elements, hence low energy peaks. It was discovered that there is a very large peak at 0.18 keV that is present in Mo-rich spectra obtained at 6 keV using the EDAX CDU Leap Detector for this research. This coincidentally is at the same peak position for boron. A small 0.18 keV peak was present in the 25 kV spectrums. Analyses were conducted to determine the identity of this peak. EDS spectra for a Mo standard were obtained at 6 kV and 25 kV, and are provided in Figure 11a and 11b, respectively. Both of these spectra have the 0.18 keV peak along with the Mo M lines at 2.29 and 2.39 keV and an oxygen peak. Therefore, it is evident that the 0.18 keV peak is characteristic of the Mo spectra as obtained with this detector.

Figure 11. EDS spectra for a Mo standard: a). At 6 kV (12-9-03 S1), and b). At 25 kV (12-9-03 S6).

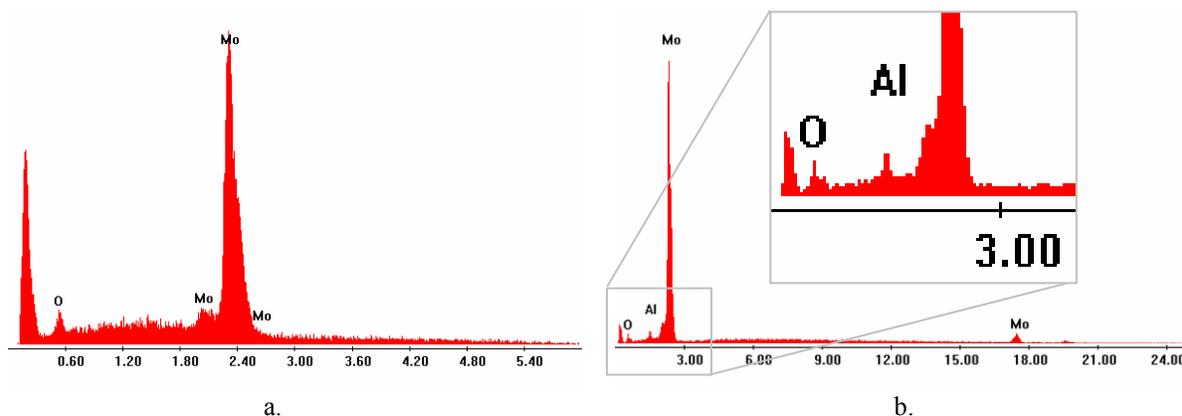
A section of a spare Mo grid was also analyzed using the EDAX CDU Leap Detector system at 6 and 25 keV. It was desired to verify the presence of the 0.18 keV Mo peak with the Mo grid material and to identify any other elements that may be present in the grid spectra. This also allowed for direct comparisons between the DC flake spectra and the Mo grid spectra by utilizing a multiple spectrum display feature in the EDS software. The sample was cut from the grid such that a fractured section of material was analyzed and the corresponding EDS spectra obtained at 6 kV and 25 kV are provided in Figures 12a and 12b, respectively. The 6 kV spectrum is very similar to the Mo standard spectrum at 6 kV, with a large peak at 0.18 keV (this peak is smaller in the grid spectrum than in the standard spectrum). The 25 kV spectrum is also similar to the Mo standard, but has a small peak identified as aluminum (Al) that is not present in the Mo standard spectrum at 25 kV.

Figure 12. EDS spectra of the Mo grid sample: a). At 6 kV (3-2-04 S1), and b). At 25 kV (3-2-04 S2).

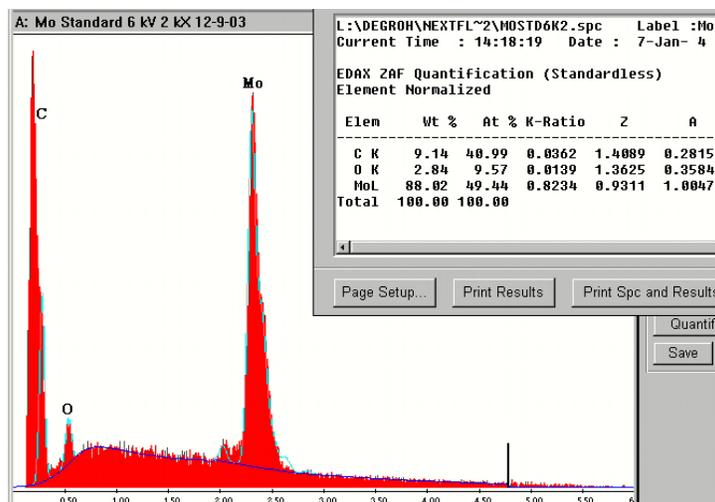
Figure 14. EDS quantification software curve fits including C for a Mo standard spectra at 6 kV.

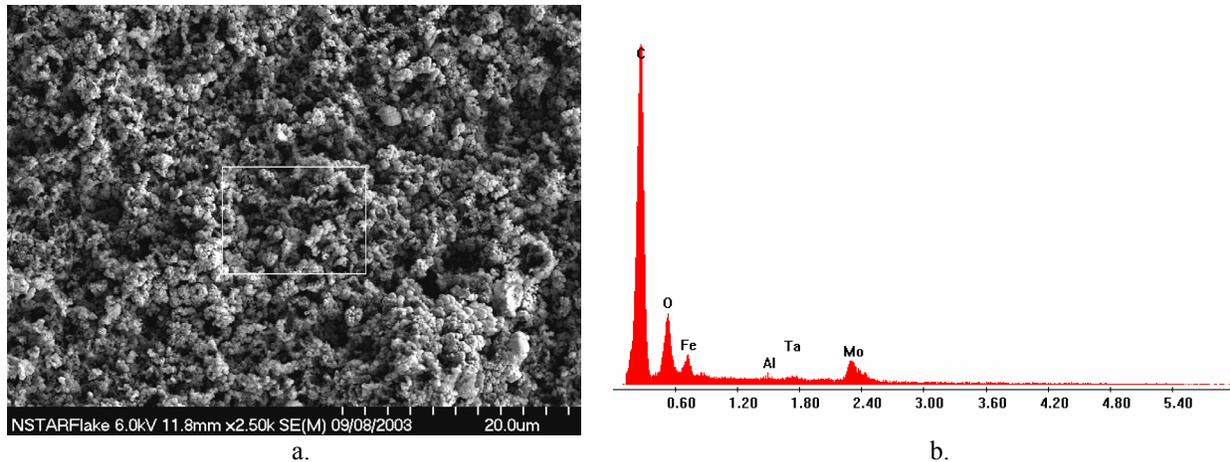
A total of 30 DC flakes were examined using the FESEM with corresponding EDS analysis. The flakes had various surface morphologies that could be described as one of the following: rough (high surface area porous texture), coated rough (appears to have a thin coating covering a rough porous substrate), rough directional (appears to have a thick coating deposited from a particular direction), coated nodules (appears as smooth little mounds) and smooth directional (appears to have a coated surface deposited from a particular direction). Examples of these surface textures are provided in Figures 15 to 19 with corresponding surface chemistry. Figure 15a provides an example of a rough surface (Flake B1 P4). The corresponding EDS spectrum obtained at 6 kV is provided in Figure 15b. This surface is comprised primarily of C (71.0 AT%) with O (17.5 AT%) and 5.5 AT% iron (Fe). There is less than 1 AT% of Al, Ta and Mo.

Figure 15. Flake B1 P4 with a rough surface morphology: a). Electron micrograph image of Flake B1 P4, and b). Corresponding EDS spectrum (9-8-03 S10) obtained from the box in the center of B1 P4.

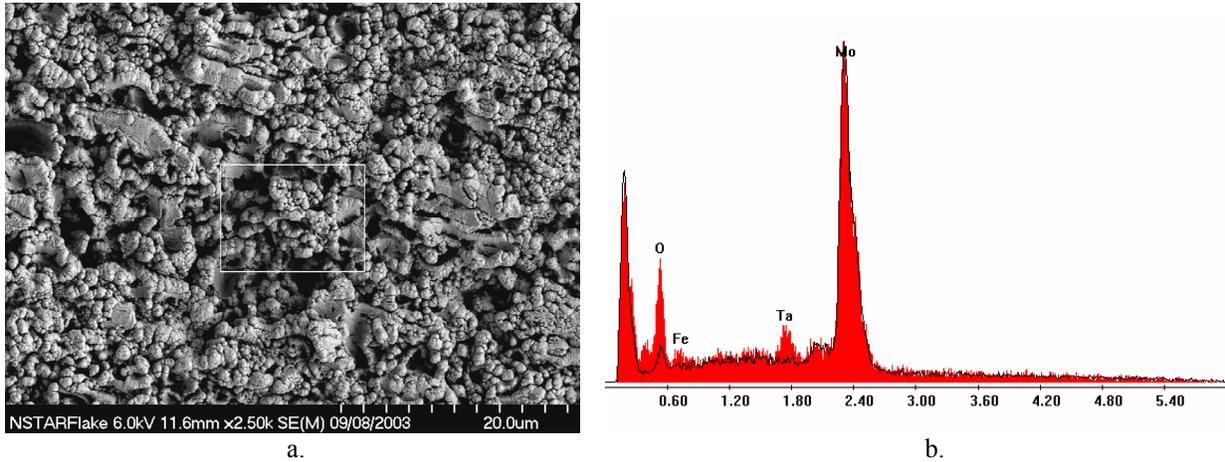
Figure 16a shows an example of a coated rough surface. The corresponding EDS spectrum for this flake (B1 P6) obtained at 6 kV (obtained at the box shown in Figure 16a) is provided in Figure 16b along with the spectrum for a Mo Grid, shown as a black line spectrum. If the quantities are computed without identifying C, the surface is found

to be comprised primarily of Mo (63.9 AT%) with O (30.1 AT%), Fe (3.2 AT%) and Ta (2.9 AT %). If the semi-quantitative analysis is computed with C (a very small C peak is observed) then the data indicates that there is less Mo (51.0 AT%) with 20.5 AT% C, along with O (23.7 AT%), Fe (2.5 AT%) and Ta (2.3 AT%). Comparing 20.5 AT% C to 19.9 AT% computed for the grid when C is identified, implies there is no substantial amount of C on the surface of this flake. This sample shows the complication of identifying the C percentage when Mo is a predominant component, and the need to compare to the Mo grid data for identifying C quantities.

Figure 16. Flake with a coated rough surface morphology: a). Electron micrograph image of Flake B1 P6, and b). Corresponding EDS spectrum (9-8-03 S12) obtained from the box area of Flake B1 P6 graphed along with the Mo grid spectrum.

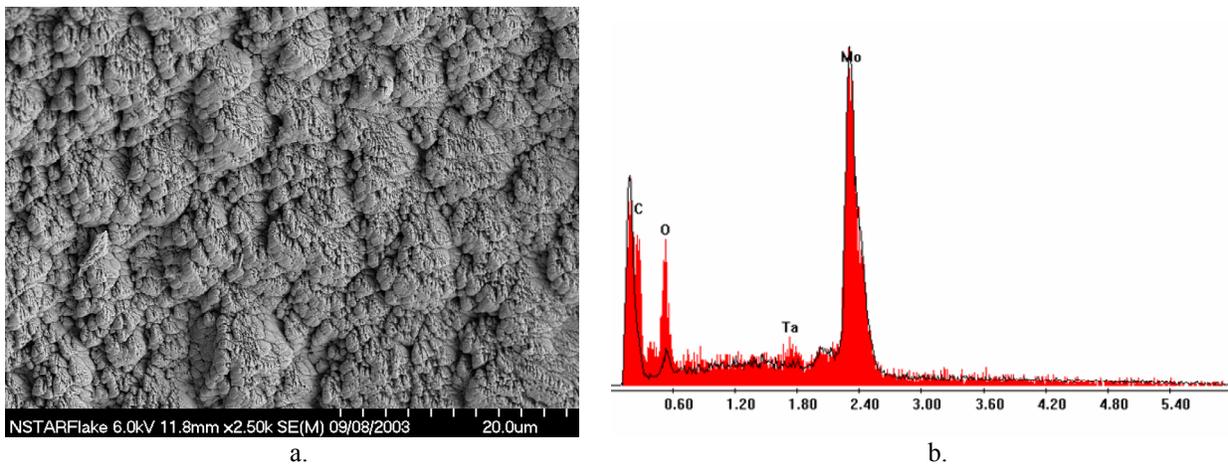
Figure 17a provides an example of a rough directional surface texture, as found on the surface of flake B1 P2. Figure 17b shows the corresponding EDS spectrum obtained at 6 kV in the central region of Figure 17a. This spectrum is similar to that for the coated rough surface shown in Figure 16b, but has a more obvious C peak. This surface is comprised primarily of Mo (43.2 AT%) with C (32.0 AT%) and O (24.8 AT%). The solid colored spectrum for the flake has been graphed along with the 6 kV black line spectrum of the Mo grid sample. The difference in the amount of O is noticeable between these 2 spectra along with the presence of C and a small Ta peak in the DC flake spectrum. Again, for this spectrum, the amount of C would be less than computed due to the presence of the Mo line at 1.8 keV.

Figure 17. Flake with a rough directional surface morphology: a). Electron micrograph image of Flake B1 P2, and b). Corresponding EDS spectrum (9-8-03 S8) obtained at the center of Flake B2 P6 graphed along with the Mo grid spectrum.

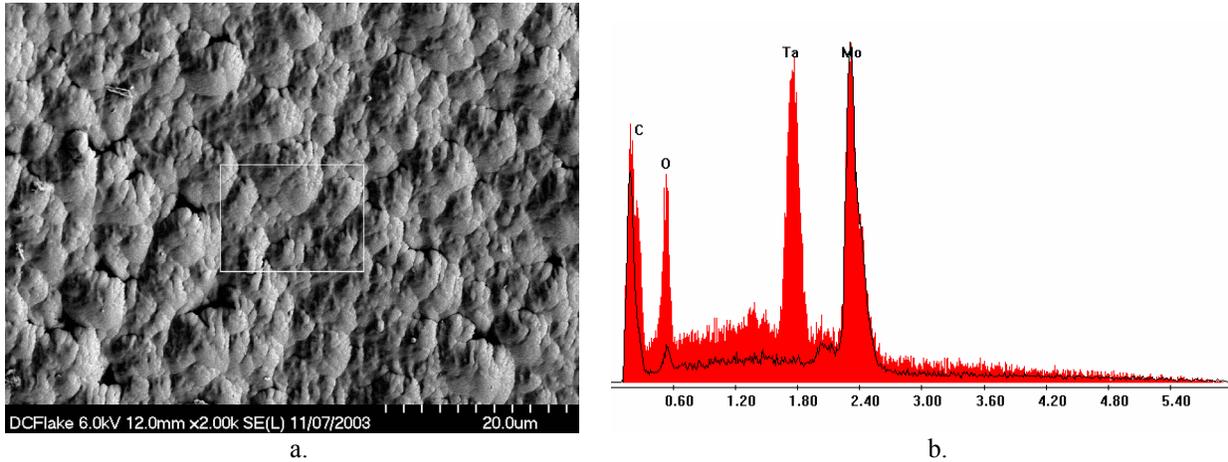
Figure 18a provides an example of a coated nodule surface texture, which look like smooth shallow mounds. Figure 18b shows the corresponding EDS spectrum obtained at 6 kV at the box location shown in Figure 18a. This surface is comprised primarily of Mo (34.7 AT%) with C (25.7 AT%), O (24.9 AT%) and Ta (14.7 AT%). The solid colored spectrum for the flake (B2 P1) has been graphed along with a black line spectrum of the Mo grid sample, also obtained at 6 kV. The difference in the amount of O is noticeable between these 2 spectra along with the presence of C and Ta in the DC flake spectrum. This flake provided the highest quantity of Ta observed.

Figure 18. Flake with coated nodule surface morphology: a). Electron micrograph image of Flake B2 P1, and b). Corresponding EDS spectrum (11-7-03 S2) obtained at the center of Flake B2 P1 graphed along with the Mo grid spectrum.

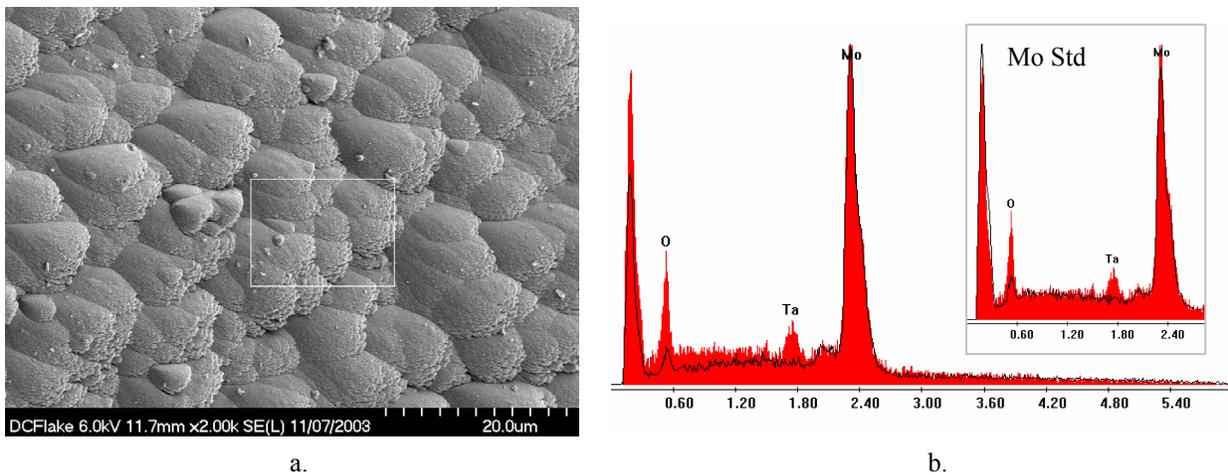
Figure 19a provides an example of a smooth directional surface texture. Figure 19b shows the corresponding EDS spectrum obtained at 6 kV at the box location shown in Figure 19a. This surface is comprised of a high percentage of Mo (64.87 AT%) with O (31.6 AT%) and Ta (3.2 AT%). The solid colored spectrum for the flake (B2 P5) has been graphed along with the 6 kV black line spectrum of the Mo grid. The insert graph shows the solid colored spectrum for the smooth directional flake (B2 P5) graphed along with a black line spectrum from a Mo standard obtained at 6 kV. In this case the fit for both the 2.29 keV and 0.18 keV Mo peaks matches very well with the standard further confirming that C is not present in the surface of this flake.

Figure 19. Flake with smooth directional surface morphology: a). Electron micrograph image of Flake B2 P5, and b). Corresponding EDS spectrum (11-7-03 S5) obtained at the box area of B2 P5 graphed along with the Mo grid spectrum. The B3 P5 spectrum graphed with the Mo standard spectrum is shown in the insert.

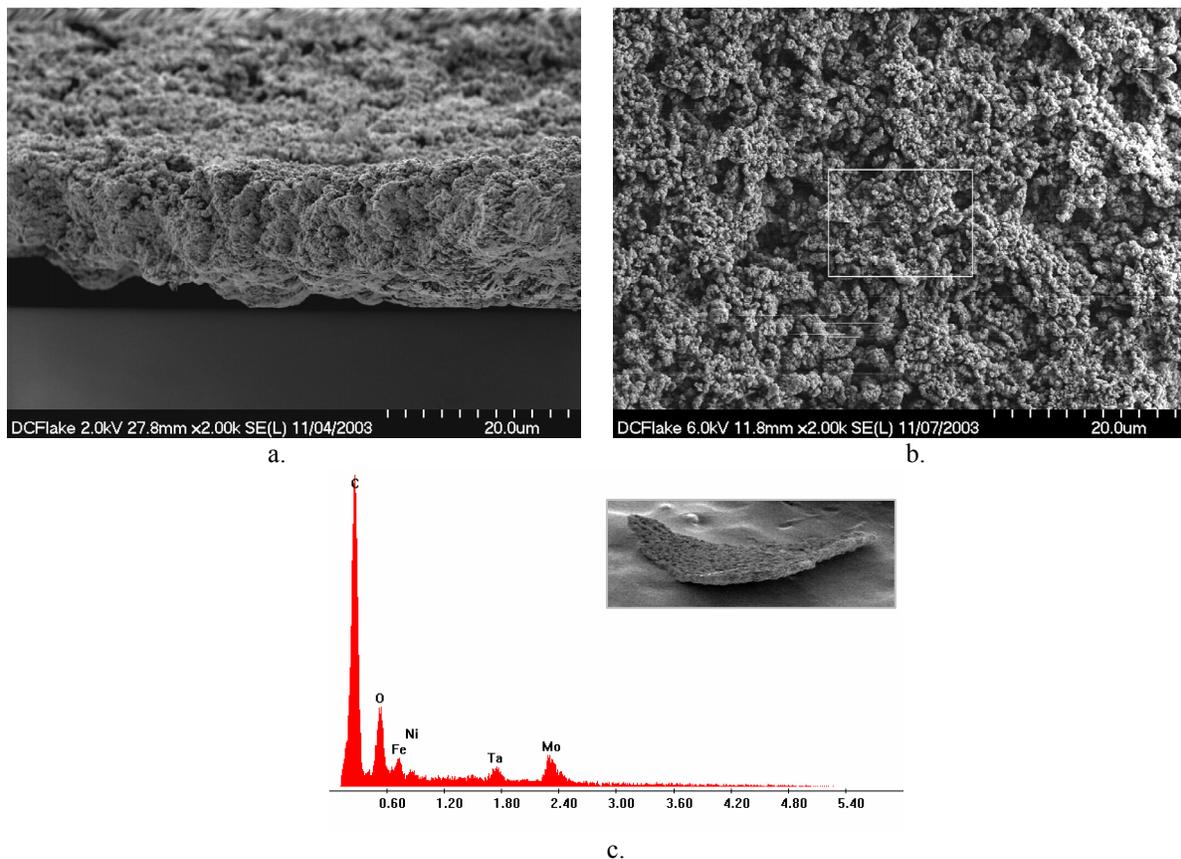
The majority of the flakes were found to be comprised of either two or three distinct layers. One flake (B2 P12) appeared to be comprised of a single layer of material. Edge and surface images of the single layer flake, which was rough and porous, and the corresponding chemistry is provided in Figures 20a to 20c, respectively. The surface, shown in 20b, is comprised of a high percentage of C (67.1 AT%) with O (19.7 AT%), Mo (6.0 AT%), Fe (5.0 AT%) and Ta (1.3 AT%). A small percent (0.9 AT%) of nickel (Ni) was also present.

It appears based on the chemistry of this single layer flake that it originated outside of the DC, likely the result of sputter erosion of the target with the resulting build-up of C on a downstream accelerator grid surface or hole wall, or the downstream face of the ground shield, that then (shortly before the end of the life test) spalled off the grid, falling into the vicinity of an accelerator hole where it was electro-statically attracted into the DC. Once such a flake lands within the DC it will gradually get coated with Mo, the primary element being deposited within the DC from ion grid erosion. Because the sputter containment mesh has a textured woven structure, the flakes arriving on the mesh could land flat and hence would be coated on one side with Mo, or the flake could land on edge (or at a titled edge) and be coated on both sides with Mo. Based on the chemistry of this single layer flake, it appears that this flake did not reside within the DC for a long period of time, because it has a small quantity (6.0 AT%) and does not have an obvious coating of Mo on either side of the C.

Figure 20. Single layer flake (B2 P12): a). Electron micrograph of the flake edge, b). Electron micrograph image of the flake surface, and c). Corresponding EDS spectrum (11-7-03 S4) obtained at the center of Flake B2 P12 shown in b).

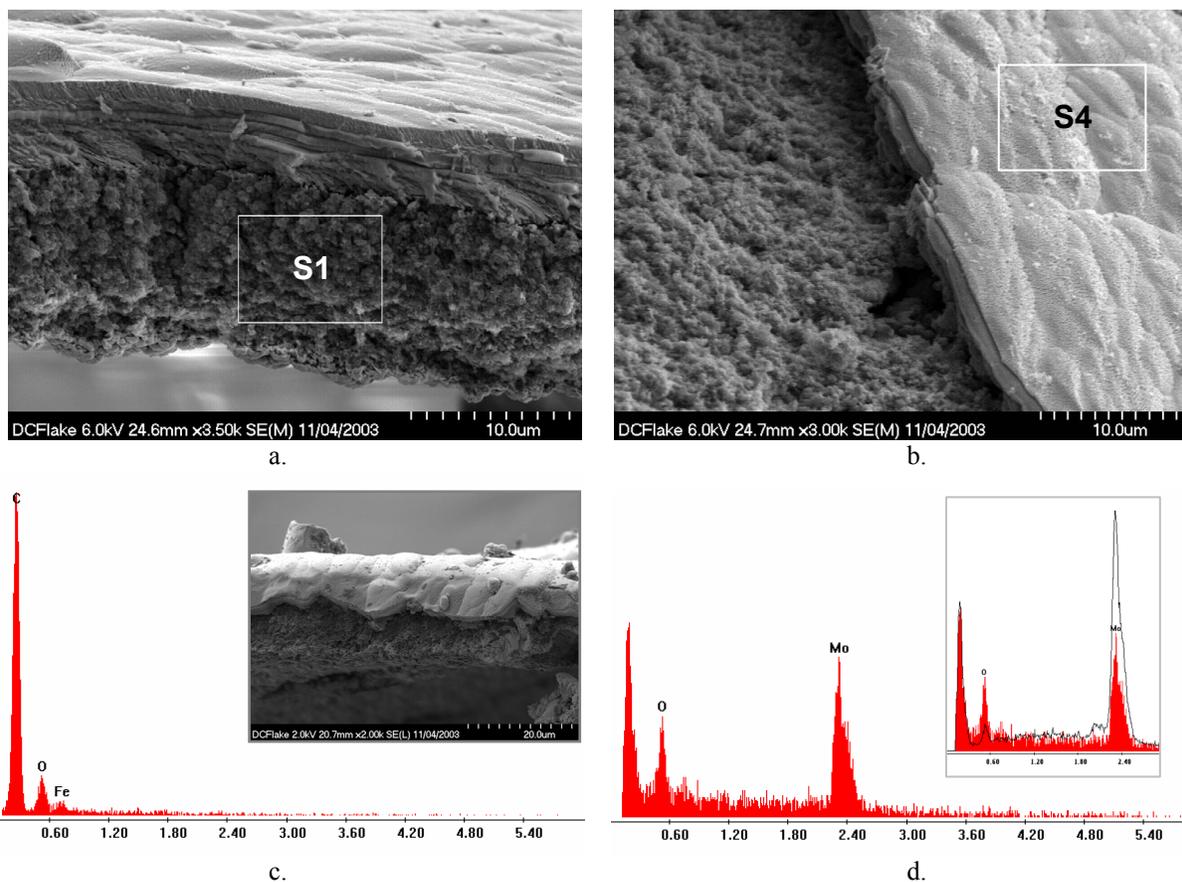
structure to it, which would be consistent with stopping and re-starting of the thruster engine. The surface image shown in Figure 21b has been taken at a step-edge. Both the top smooth layer and the underlying bottom rough layer are visible in this image. The corresponding EDS spectrum for the rough thick bottom layer is provided in Figure 21c. It was obtained at the box location (S1) shown in Figure 21a. This thick rough layer is comprised primarily of C (83.2 AT%) with O (12.9 AT%) and Fe (3.8 AT%). The EDS spectrum for the smooth top layer is provided in Figure 21d. The flake spectrum is shown compared to the Mo grid spectrum in the figure insert. It was obtained at the upper right box location (S4) shown in Figure 21b. This smooth solid top layer is comprised of Mo (56.3 AT%) and O (43.7 AT%). This two layered flake can be characterized as a Mo-C flake. It is consistent with a C-rich downstream flake spalling off and arriving flat in the DC and residing long enough for a thick Mo layer to deposit on the exposed surface. The inserted electron microscope image shown in Figure 21c shows an area where the top Mo layer is wrapped down and partially around the edge. This provides a visible example of how the Mo can cover an underlying layer of C.

Figure 21. Two layered flake (B2 P3): a). Electron micrograph of the flake edge showing two distinct separate layers, b). Image of the flake surface at a step-edge, c). EDS spectrum (11-4-03 S1) of the rough layer obtained at the box shown in a), insert image shows a Mo surface coating wrapping around C base layer, and d). EDS spectrum (11-4-03 S4) of the smooth top layer obtained at the box shown in b).

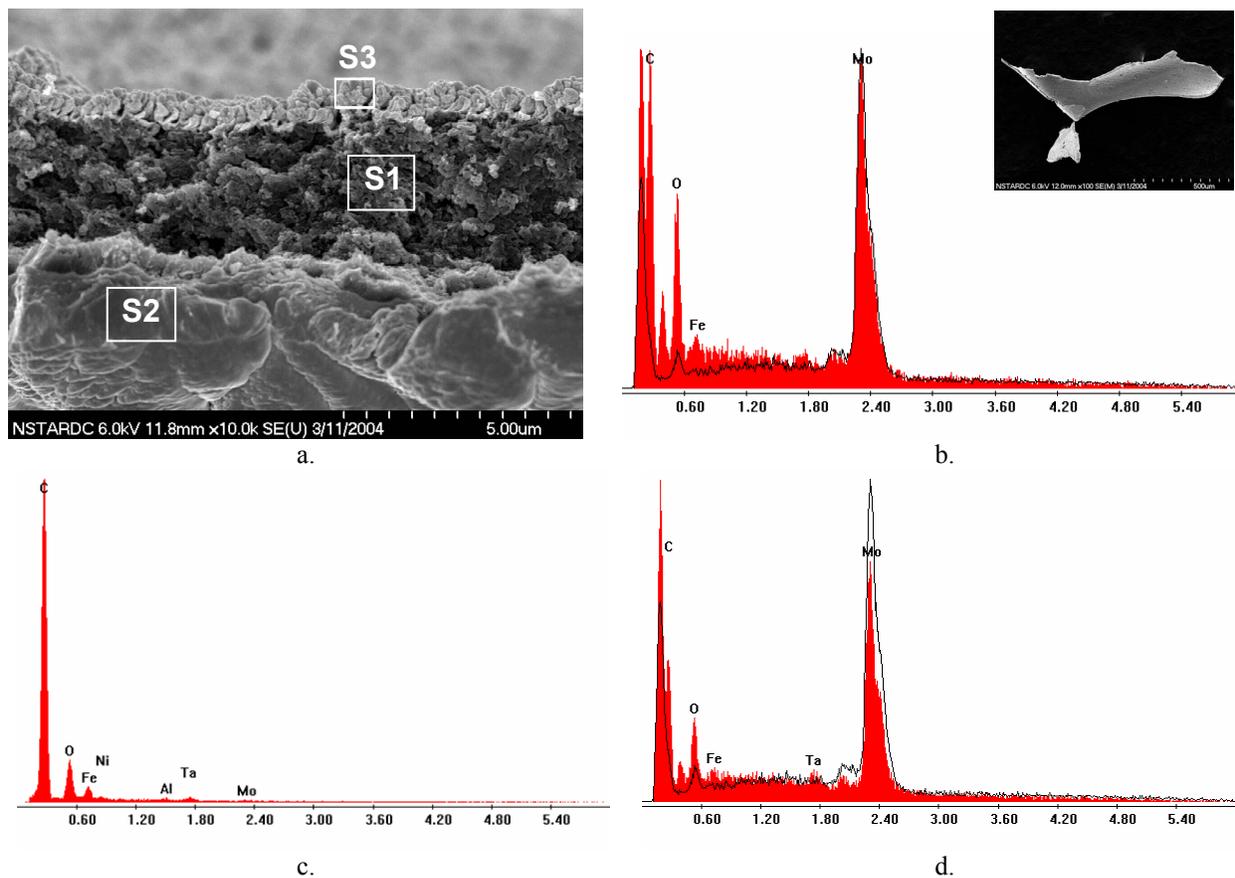
Figure 22 provides an example of a three layered flake (B4 P1). This flake is 1.195 mm in length. A broken edge view of the flake is provided in Figure 22a and clearly shows three very distinct layers. The top layer in this image is a thin wavy layer. The center layer is a thick rough layer and the bottom layer is a rough nodular layer. The corresponding EDS spectra for these 3 layers are provided in Figure 22b to 22d, respectively. The EDS spectrum for the thin top layer is provided in Figure 22b and was obtained at the Box labeled S3 in Figure 22a. This layer is comprised of C (46.2 AT%), Mo (30.5 AT%), O (20.6 AT%) and Fe (2.7 AT%). The thick rough central layer is comprised primarily of C (79.1 AT%) with O (13.3 AT%) and Fe (5.3 AT%). There was less than 1 AT% of Al, Ta and Mo. The EDS spectrum was obtained at box S1 shown in Figure 22a. The EDS spectrum for the thick bottom layer is provided in Figure 22d and was obtained at box S2 in Figure 22a. This layer is comprised of

Mo (41.0 AT%), C (40.1 AT%), O (15.4 AT%), Fe (2.4 AT%) and Ta (1.1 AT%). An EDS spectrum was obtained on the surface of the thin top layer (3-23-04 S27), which indicated that this layer was comprised of Mo (66.2 AT%) with O (29.8 AT%) and Ta (4.0 AT%), with a very small C peak. The surface analysis performed on the flat section of the flake would provide more accurate EDS data than the spectrum obtained at S3. Therefore, this three layered flake can be characterized as a Mo-C-Mo flake. This flake is consistent with a C-rich downstream accelerator grid surface flake spalling off the grid and arriving in the DC on a tilted angle and residing long enough for Mo layers to deposit on both exposed surfaces.

Figure 22. Three layered flake (B4 P1): a). Electron micrograph of the flake edge showing three distinct layers, b). EDS spectrum (3-11-04 S3) of the thin top layer obtained at the box shown in a), c). EDS spectrum (3-11-04 S1) of the rough center layer obtained at the box S1 shown in a) and d). EDS spectrum (3-11-04 S2) of the thick bottom layer obtained at the box S2 shown in a).

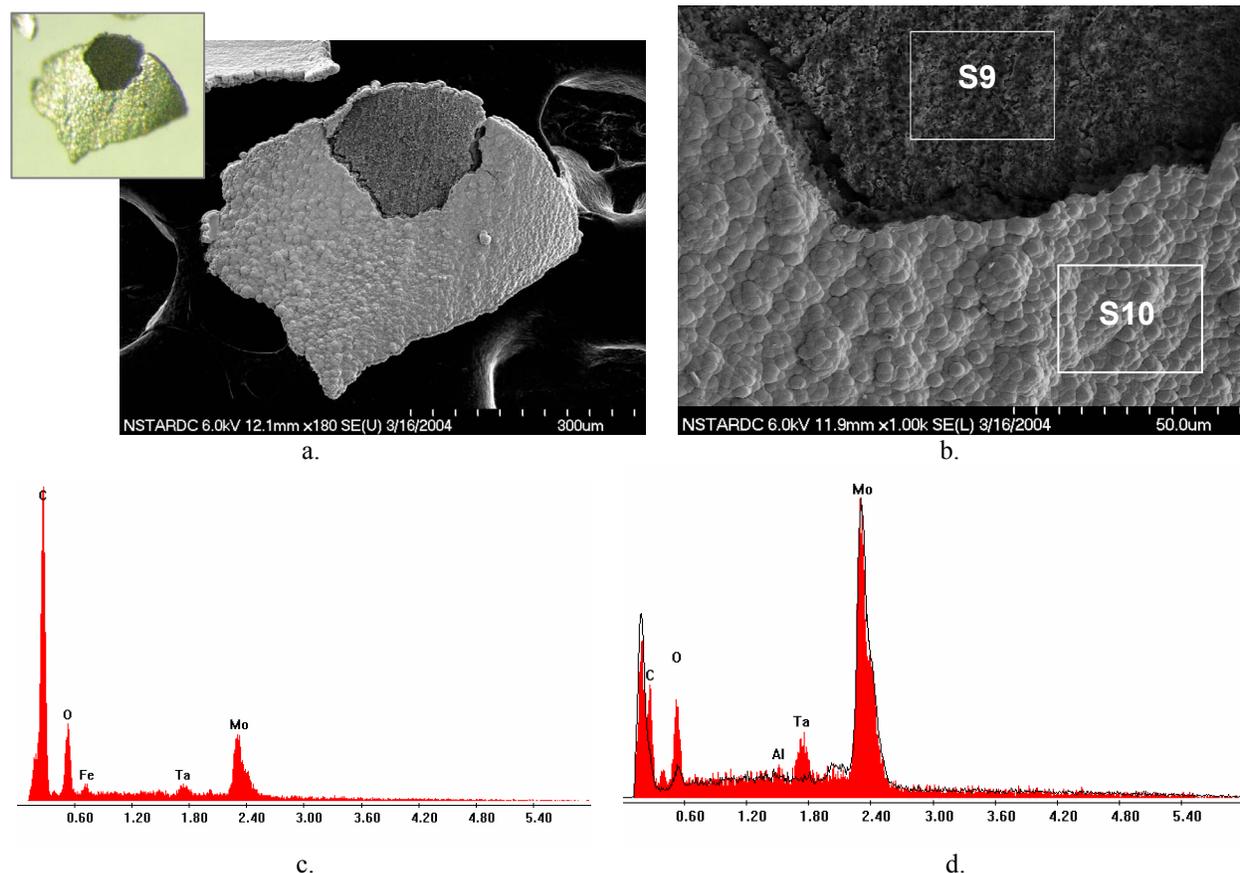
subject to Mo coating within the chamber. A dual-texture flake might also be the result of a 2 or 3 layered flake in which a portion of a Mo surface layer breaks off the flake during flake handling.

Figure 23. Dual-texture flake (B4 P5): a). Electron micrograph of the Flake B4 P5 showing two distinct textures, along with an optical microscope image insert, b). Electron micrograph showing a close-up of the dual-texture transition area, c). EDS spectrum (3-16-04 S9) of the dark rough layer obtained at box S9, and d). EDS spectrum (3-16-04 S10) of the nodular texture layer obtained at box S10.

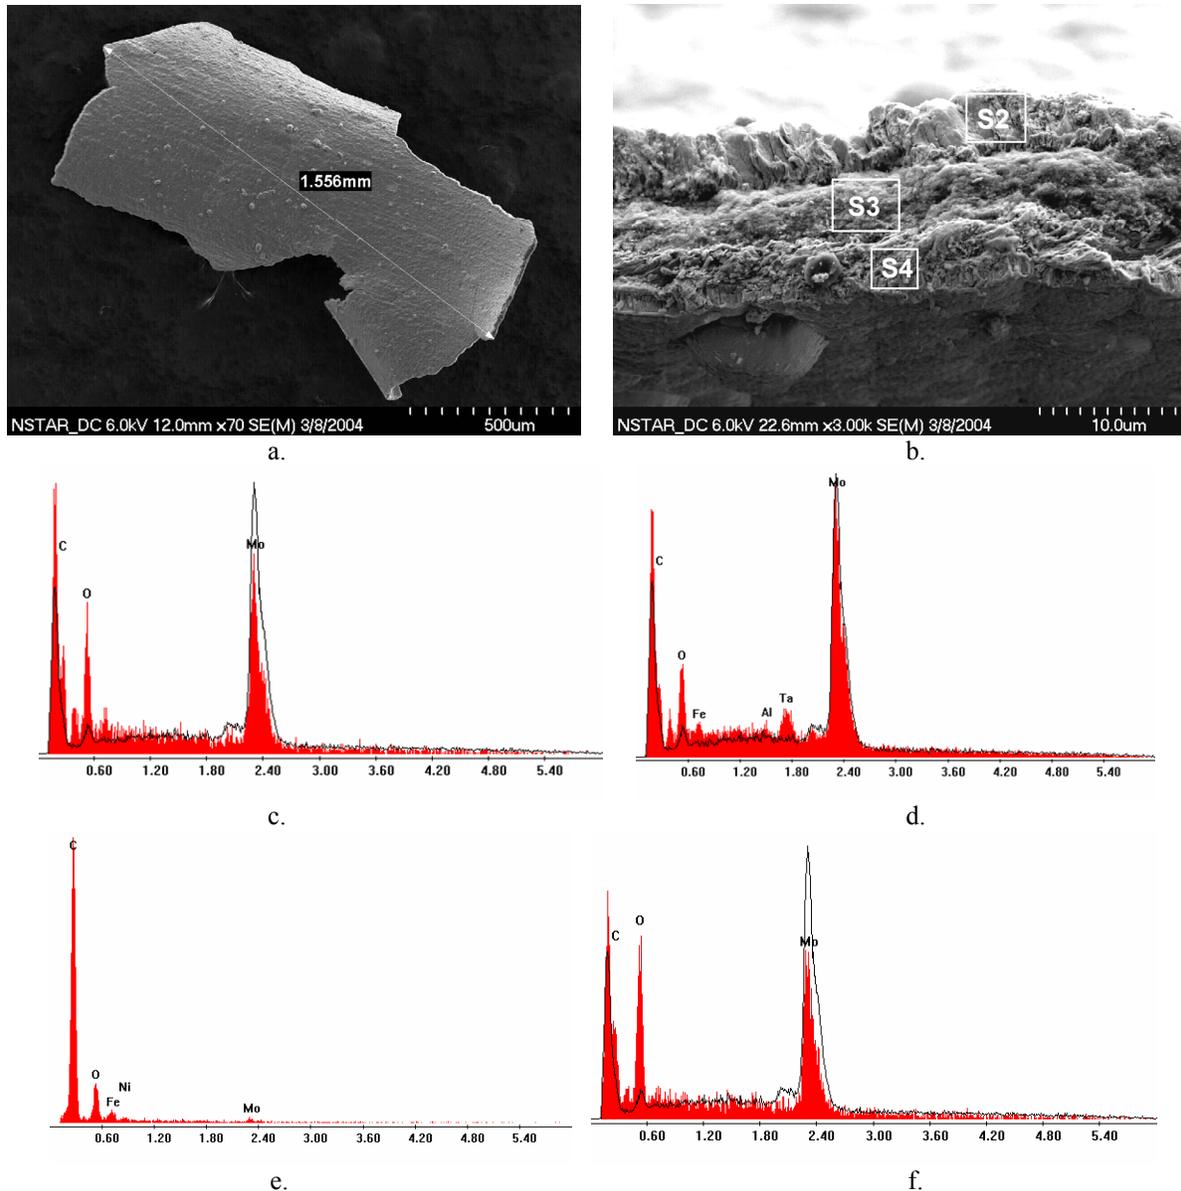
Figure 24 is the largest DC flake analyzed with the electron microscope. This flake (B3 P1) was from the DC Flakes 3 container and is 1.556 mm in length. Figure 24a shows an FESEM image of the flake, while Figure 24b shows an image of a broken edge. Although the electron image does not clearly show it, this flake is a 3 layered flake. The EDS spectra for the 3 layers are provided in Figures 24c to 24f. The EDS spectrum of the top layer was collected at box S5 shown in the edge image and is comprised of Mo (36.7 AT%), C (32.0 AT%) and O (31.2 AT%). An EDS spectrum of this layer was also obtained as a surface scan (orientation as shown in Figure 24a) and is provided in Figure 24d. This spectrum indicates that there is a higher percentage of Mo (48.3 AT%) with less C (22.1 AT%) and O (21.4 AT%), and small amounts of Fe (4.2 AT%), Ta (2.6 AT%) and Al (1.4 AT%). The EDS spectrum for the center layer, indicated by S3 in the edge image, is provided in Figure 24e and indicated that it comprised of a high quantity of C (79.2 AT%) with O (14.7 AT%), Fe (4.2 AT%) and Mo (1.3 AT%). There was less than 1 AT% of Ni. The spectrum for the bottom layer, indicated by S4 in the edge image, is provided in Figure 24f and shows a highly oxidized surface with 39.9 AT% O along with Mo (32.8 AT%) and C (27.3 AT%). This large three layered flake can be characterized as a Mo-C-Mo flake. Again, having a central C-rich layer, this flake is consistent with the origin being the build-up of C on a downstream surface.

Figure 24. The largest analyzed DC flake (B3 P1): a). Electron micrograph of the flake, b). Electron micrograph showing a broken edge area, c). EDS spectrum (3-8-04 S5) of the top layer obtained at box S5, d). EDS spectrum (3-8-04 S1) of the surface of flake B3 P1 (top layer surface spectrum) shown along with a Mo grid spectrum (black line), e). EDS spectrum (3-8-04 S3) of the center layer obtained at box S3, and f). EDS spectrum (3-8-04 S4) of the bottom layer obtained at box S4.

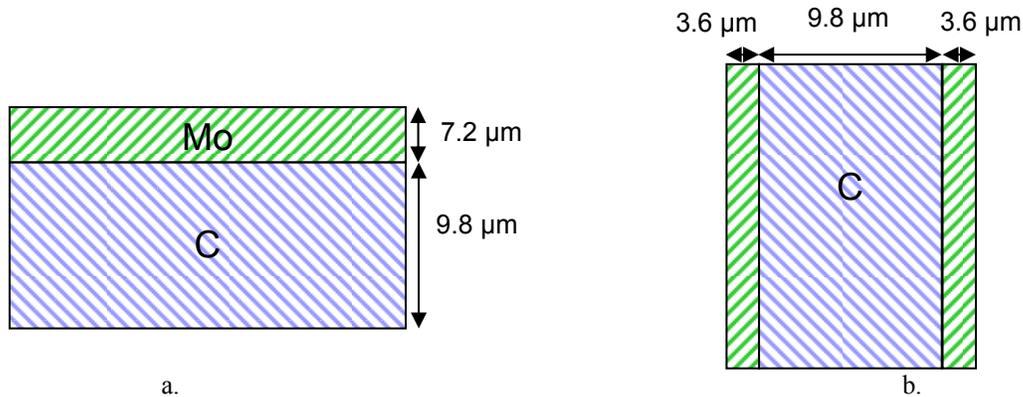
Based on DC flake edge thickness measurements, the flakes were found to vary in thickness from 7.7 to 28.9 μm , but were typically from 13.2 to 20.6 μm . For the flakes whose cross-section C layer was visible, it was found that the C layer varied from 7.8 to 12.3 μm thick. The average thickness for the C layer (10.1 μm) is consistent with the average C thickness (9.8 μm) computed based on mass loss. The C-based single layer flake had a thicker C layer at 14.4 μm .

Figure 25. Schematic representation of the flake geometries based on mass loss calculations: a). Two layer flake geometry, and b). Three layer flake geometry.

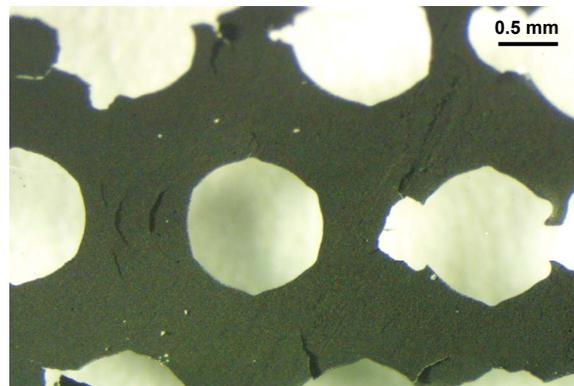
An optical microscope image of one of the large downstream accelerator grid surface flakes is shown in Figure 26. The nonsymmetrical shape of the grid holes are reflected in this debris flake.

Figure 26. Downstream accelerator grid surface flake.
